Aging Behaviour & Resistance of Ceramic Insulators

Markku Ruokanen, ITG Group Quality and R&D Director
Erik Lehmann, Linear Assets, 50Hertz Transmission GmbH

KEYWORDS: Ceramic Aging, Long Rod Insulators, Overhead-line insulators, Failure Modes

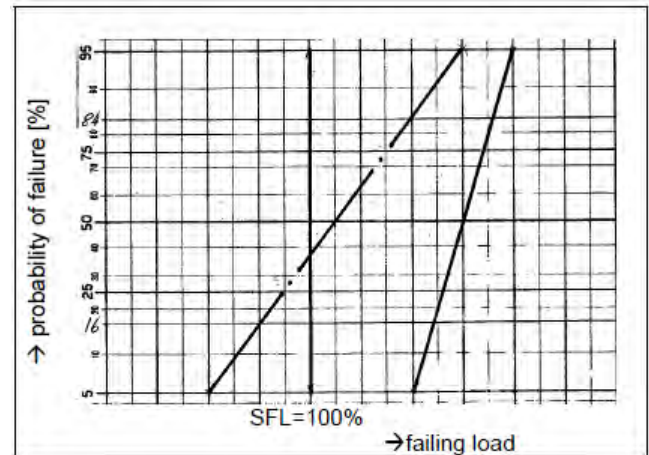
Diagram 1: Scenario F3 from Cigré TB 306₍₁₎, where the solid line presents failing as arrived and the dashed/dotted line after the TMP testing.

We can see on the diagram how the artificial aging has moved the failing load on left and it is crossing the Specific Failing Load at 35 % probability. The demonstrates advanced aging even when the insulators were good as received. In such case the recommendation would be to repeat the test in couple of years and see if the as arrived have been further deteriorated.

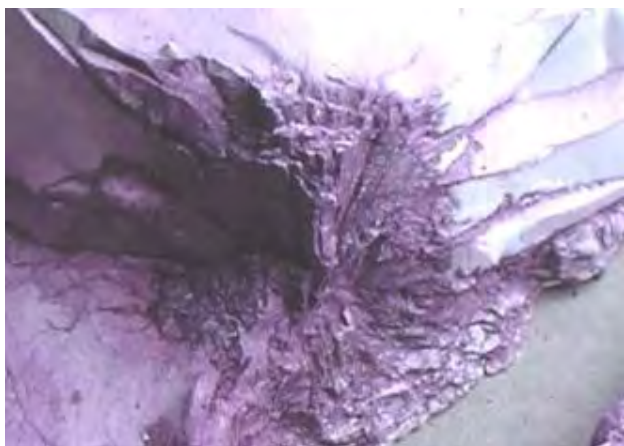
The structure C-130 consist of Corundum (35 – 40%), Mullite (10 – 15 %), Quartz (< 2 %) and the rest is glass phase (SiO₂). The presence of Quartz should be avoided (7), but recent studies have shown that size of quartz particles is more critical than the quantity (4,5).

Photo 1: Quartz initiated crack growth in a long rod. Quartz content > 2%

Anyhow high residual quartz content increase the probability that of bigger particles and bigger initial cracks on the cooling. There are different values for the critical quartz size threshold: 10 μm (5) 20 μm (6)

and 50 μm (7), the reality is probably around 20 μm depending of the microstructure.

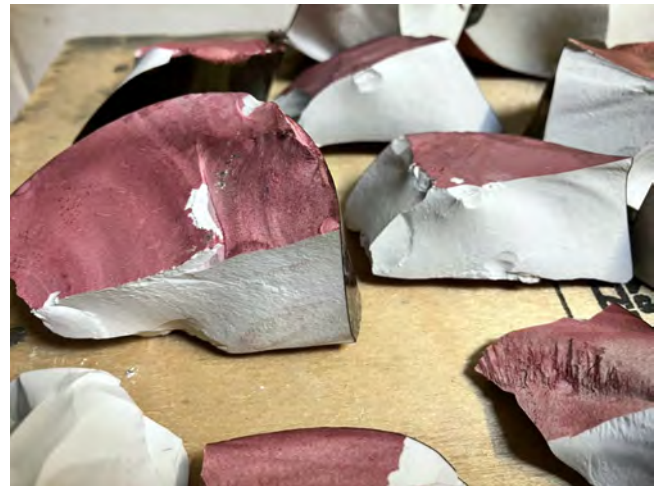
There is always some porosity on ceramic materials, C-120 and C-130 are tight fired, developed for this propose, which means that there is no open porosity which would allow moisture absorption and crack propagation in low temperatures(8). Normally the porosity density is about 10-15 % and the pore sizes being about 5 μm - 10 μm , which is not causing significant sub-critical crack propagation (9). When the pore-size is higher than 20 μm it can be considered as material defect, but these are nowadays extremely rare.

Photo 2: C-130 body pieces on the porosity test samples according to IEC 60383-1 § 26 (10), no porosity.

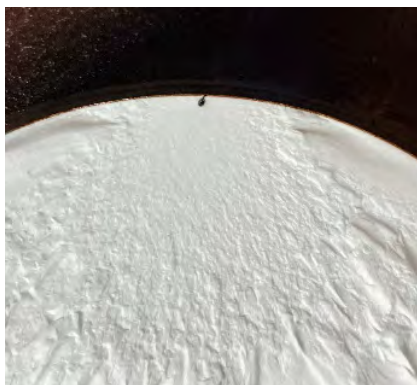
This is called “iron particle” or “black dot”. The particle can be iron, or it can be any other metal, which is a foreign particle. These particles can come from raw-material or from contamination on the logistic chain. One root cause is that the truck has been used to transport other materials or even waste, which contaminates the delivered raw material. Another root cause can be the recycling of big bags, without proper cleaning.

Photo 4: An iron particle on breakage surface on a tensile test, clearly visible and can be identified as a place to the critical crack propagation.

The iron contamination can as well happen in manufacturers own warehouse, especially if that happens outdoor. Normally a proper silo-warehousing protects the raw material quite well.

To eliminate the iron particles, manufacturers have installed strong magnets and sieves on the pipes on which the slurry is pumped to the filter presses.

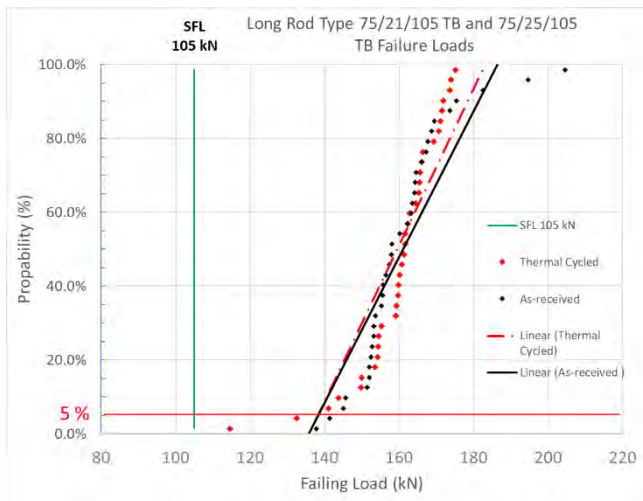
Diagram 2: Long rods 75/21/105 TB and 75/25/105 TB plot as defined by TB 306.

The first observation is that the failing load was normally distributed.

The failure load values were 161 kN for the as-received lot and 150 kN for the thermally cycled, both groups were having good standard deviation of 12 kN. The SFL at 5 % probability was 31 %. The scatter for both groups was 8% and considered as normal.

The 1st conclusion is that there is no field aging causing sub-critical crack grown, which would be

visible on laboratory artificial aging with thermal cycling.

TB 306 doesn't include any closer failure analysis and mineralogical study in the assessment. This is strongly recommended: in this study the diagram 2 is proposing that that insulators are like new after 33 years' service. Only the failure mode analysis shows that there is a 17 % fraction of insulators which were sensitive to the accelerated aging due material defects. If the test is repeated in 10 years and the ratio 12 ceramic failures/60 cap failures moves, it would be an indication, that ceramic aging has been accelerating and more cracks was initiated between 33 and 43 years.

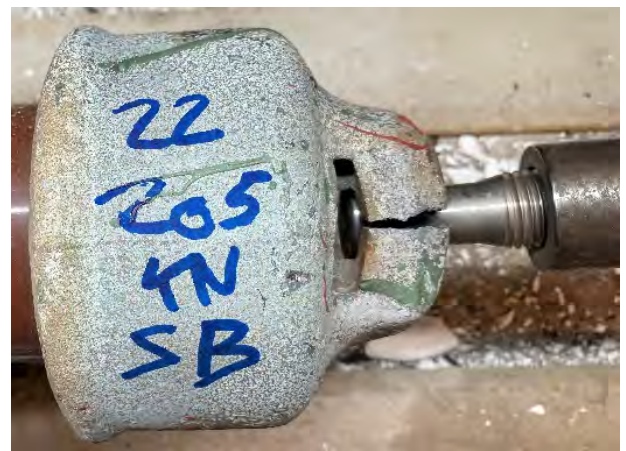
When analysing the failure modes, it was first observed that majority of the failures were on cast iron CAP, 60 insulators of 72, presenting 83 % of the failures. The failure was always in same place and the broken cap didn't show any specific material defects: like porosity, casting inclusion, big grains, or corrosion damages. The average failure force was 162 kN with 11 kN Standard deviation. The 2nd conclusion was that the caps didn't show any aging but were just

design point of view the weakest point.

Photo 5: Typical Long Rod 75/21/105 TB Cap failure.

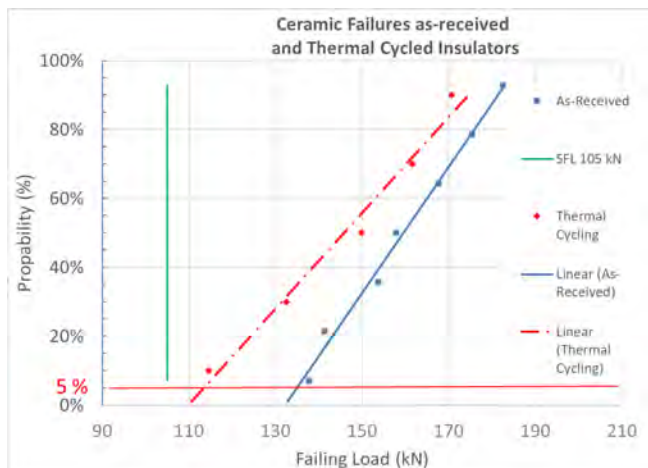
It was a hazard that of the 12 insulators failing on ceramic body, 7 were broken as received and 5 were thermally cycled before the testing. This allowed us to

Diagram 3: Failures on ceramic body of long rods 75/21/105 TB and 75/25/105 TB plotted as received and thermally cycled.

It is obvious that 7 and 5 samples are statistically not enough to make any kind of conclusion and statements. Anyhow this plot, which looks 100 % identical to scenario F5 of the TB 306, raises more questions than is giving answer and does merit a discussion.

On the diagram 3 we can see how the 12 porcelain failures are plotted in the probability diagram and looks like the scenario 5 on the TB 306. But using the scenario 5 for conclusion would be misleading. We have here a situation where a population 12 pieces of 72 failed on porcelain and it was possible in 9 to identify a material defect where the critical crack propagation started.

Anyhow 7 of these insulators tested as-received were having an average failure load of 159 kN which is

same to the average of all the 60 Cast Iron Cap failure loads 161 kN. This is suggesting that there has not been statistically significant aging of the long rods after 33 years in the service.

Then the 5 of the 12, which passed the thermal cycling test according to IEC 60383-1 § 23 had 146 kN average failure load so lost about 9 % of the mechanical strength when compared to the 7 tested as-received. This is quite brutal aging with only 3 thermal cycles of 70 K delta. Couple cycles more and the line would move left-hand side of the SFL 5%.

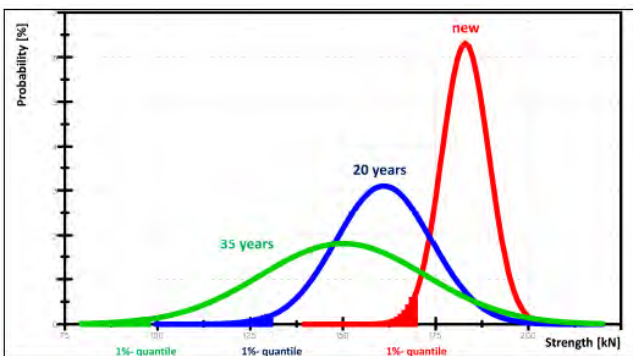
The If we now look again at Freese & Pohlman graph⁽⁸⁾, we see that in this project the mechanical performance after 33 years' service is much better than proposed in 1999.

Diagram 4: Statistical long rod life-time assessment by Freese and Pohlman.

Anyhow it is evident that only one study is not statistically enough to confirm that these “20 years” and “35 years” gaussians could be moved more on

right-hand side. But the topic is worth to be discussed and other studies should be launched.
