Field Ageing Behaviour of Long Rods Analysed According Cigré TB 306

KEYWORDS: Cigré TB 306, Long Rod Insulators, Overhead-line Insulators, Ceramic Failure modes, Lifetime, subcritical crack growth in ceramics.

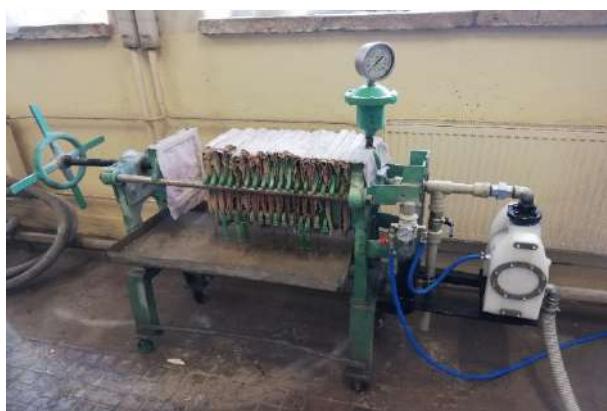
Fig 1. The laboratory filter-press

The quartz particles 1 wt.% were mixed into the base-body in the laboratory mill. For baseline test-bars with 0 wt.% quartz was made of the same batch of body. The body was pressed in the laboratory (Fig. 1) and extruded with the laboratory extruder (Fig. 2) to 10 mm diameter and 150 mm long test-bars.

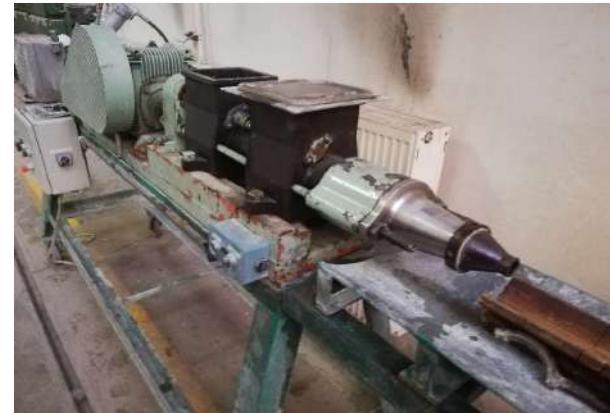
Fig 2. The laboratory extruder.

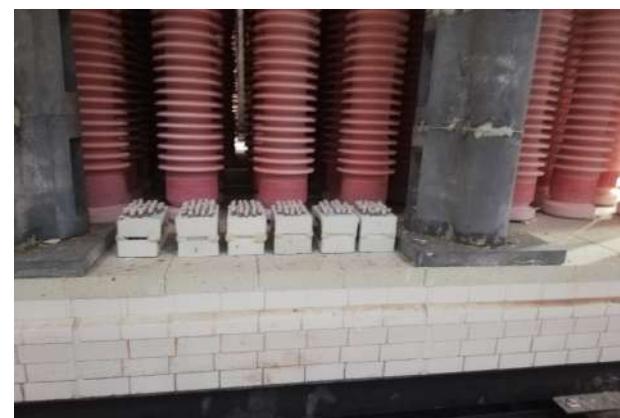
Fig 3. Samples ready on kiln for firing.

After extrusion, the test bars were fired in the production kiln (Fig. 3)

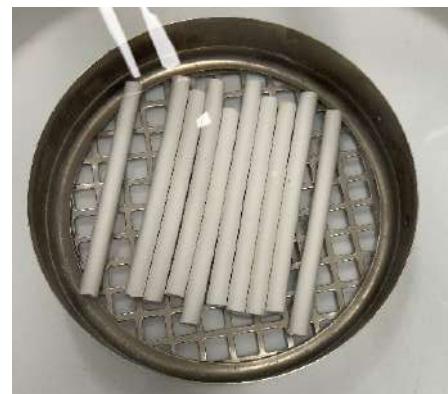
Fig 4. Test bars immersed on 20°C water.

The fired samples were put in thermal shock test according to IEC 60672 § 11, Method A (5). 10 samples were heated in oven at 120 °C +/- 5 °C, over 2 hours and quickly immersed on water 20 °C staying there 5 minutes. (Fig. 4)
